SOMERVILLE CITY HALL

CPA FUNDING APPLICATION PACKET

EXISTING CONDITIONS REPORT SOMERVILLE CITY HALL

The City of Somerville has commissioned CDR Maguire Inc. to perform a comprehensive building assessment of the Somerville City Hall to identify existing building deficiencies, prioritize their repairs and provide an associated construction costs to perform the identified issues.

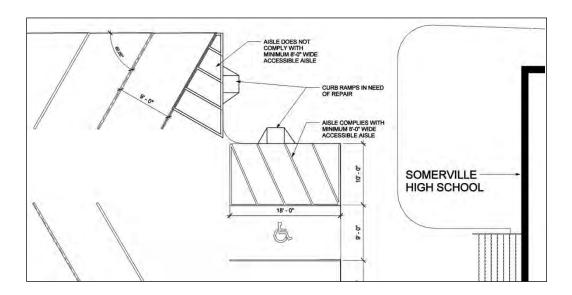
Enlarged area of accessible parking

also damaged and in need of patching.

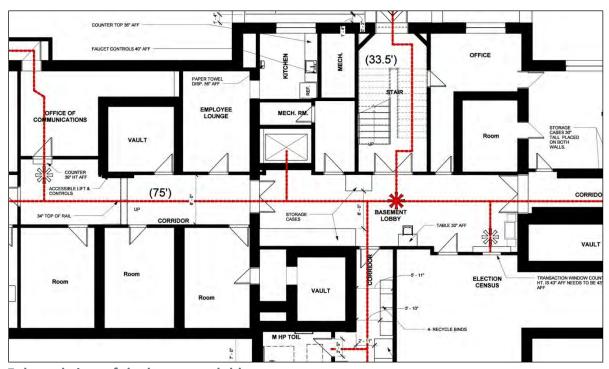
Enlarged view of the basement lobby

Wherever there is interaction between city personnel and general public, it is mandatory to provide a portion of the public access counter or an auxiliary counter that is a minimum of 36" long and is no higher than 36" above the floor There needs to be an area that is minimum 30" x 48" for a single stationary wheelchair and occupant to allow a forward approach.

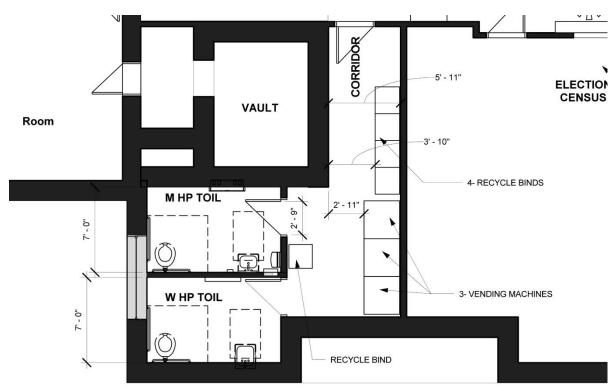
Enlarged view of the basement toilets

1. Basement Bathrooms: Pipes and radiators are badly rusted and unsightly. See photo 18. Mechanical ventilation, a Code requirement, is absent. Slide bolt locks at bathroom doors interfere with power door operators and are not handicap compliant. Inadequate stalls cause inconvenience.

Photo 18 - Basement bathrooms are single-user, causing inconvenience. Rusty pipes and radiators, mismatched accessories, unpleasant lighting and deteriorated floors give unattractive appearance.

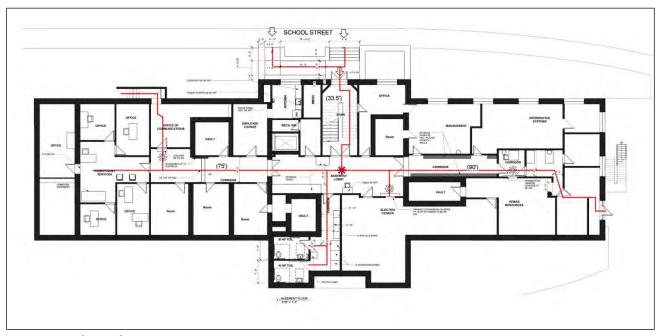
Basement Floor Plan

There are three means of egress from the basement floor to the exterior, the exit door from the office of Communication in the south wing, the exit at Human Resources department in the north wing and the monumental Stair 1. The monumental Stair 1 does not qualify as a rated means of egress because the partitions separating it from the lobbies at every floor are not rated. Some of the exits are through adjoining spaces which will need to remain unlocked if used as such.
